FIELD INSPECTION

Project Name:	Mountain Valley Pipeline	Inspector:	Matthew Grant
Inspection Date:	Wednesday, January 9, 2019	Project Contact:	Brian Clauto
Spread: Franklin County MP 266 MP273, MP275, MP276	Spread I	Weather (Wet/Dry/Rain):	Wet

FIELD INSPECTION PHOTO LOG

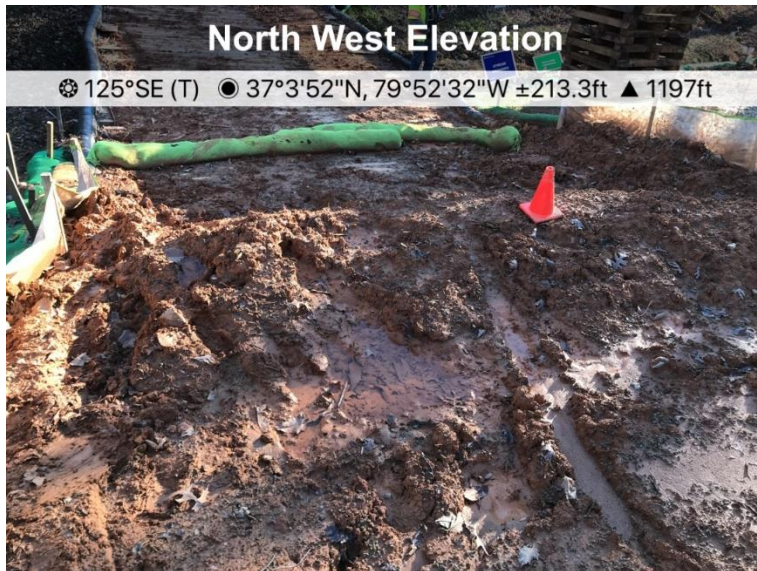
- Fig. 1 Waterbar at St#14065+80 has eroded.

Recommended Corrective Action: Remove off site sediment per DEQ approval and maintain all controls per the approved plan and specs.

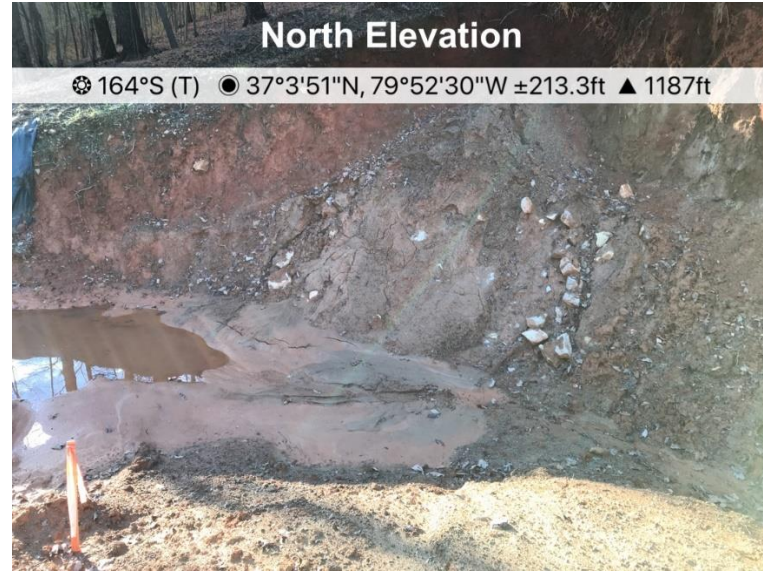
- Fig. 2 Sump near St# 14065+80 requires maintenance

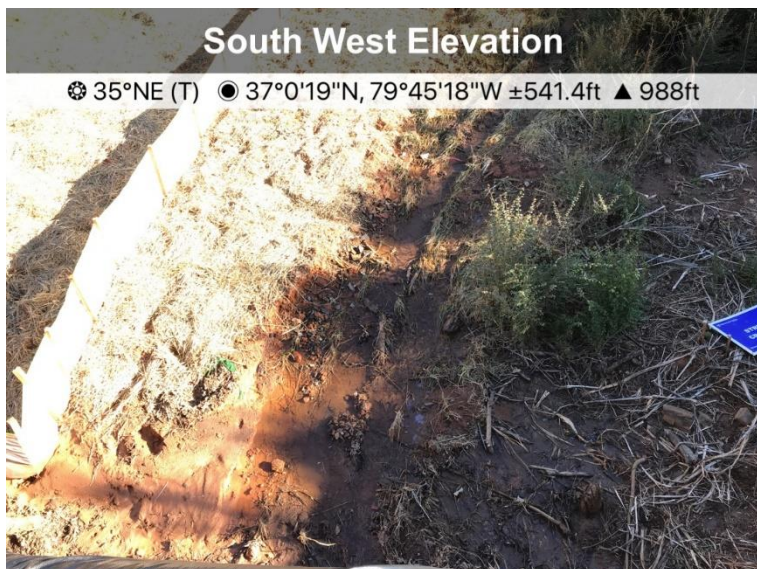
- Fig. 3 Sediment was observed at designated stream SG-17 at St#14546+00 MP 275

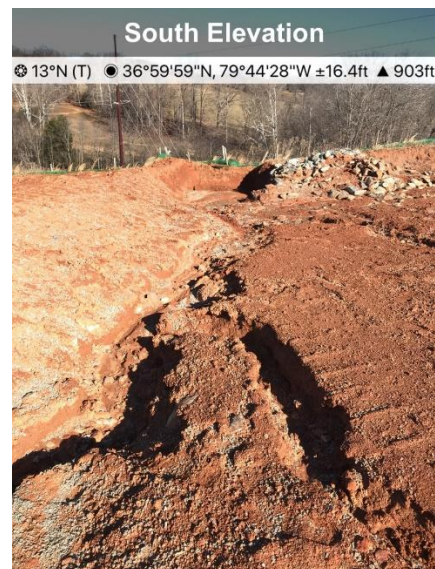
- Fig. 4 Waterbar & sump at St14587+00 has erosion in flow path and sump requires clean out.

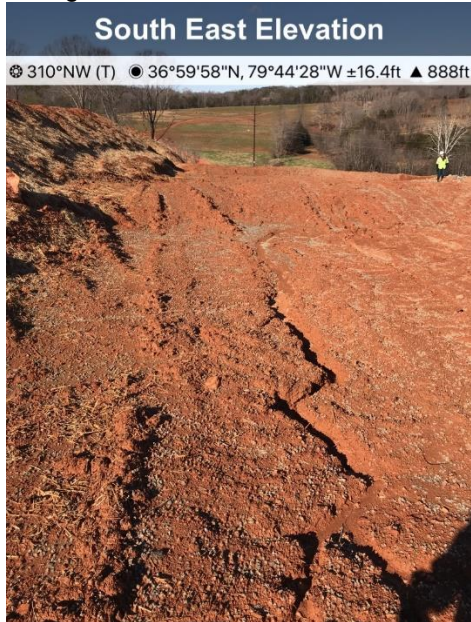
- Fig. 5 Between St#14583-14589 lacks adequate stabilization
